HATCHIE

BIG LAKE DAM
INSPECTION REPORT

BIG LAKE DAM
ON A TRIBUTARY OF HATCHIE CREEK
A TRIBUTARY OF THE MISSISSIPPI RIVER
HAYWOOD COUNTY
TENNESSEE

FEDERAL INVENTORY NUMBER TN 07505

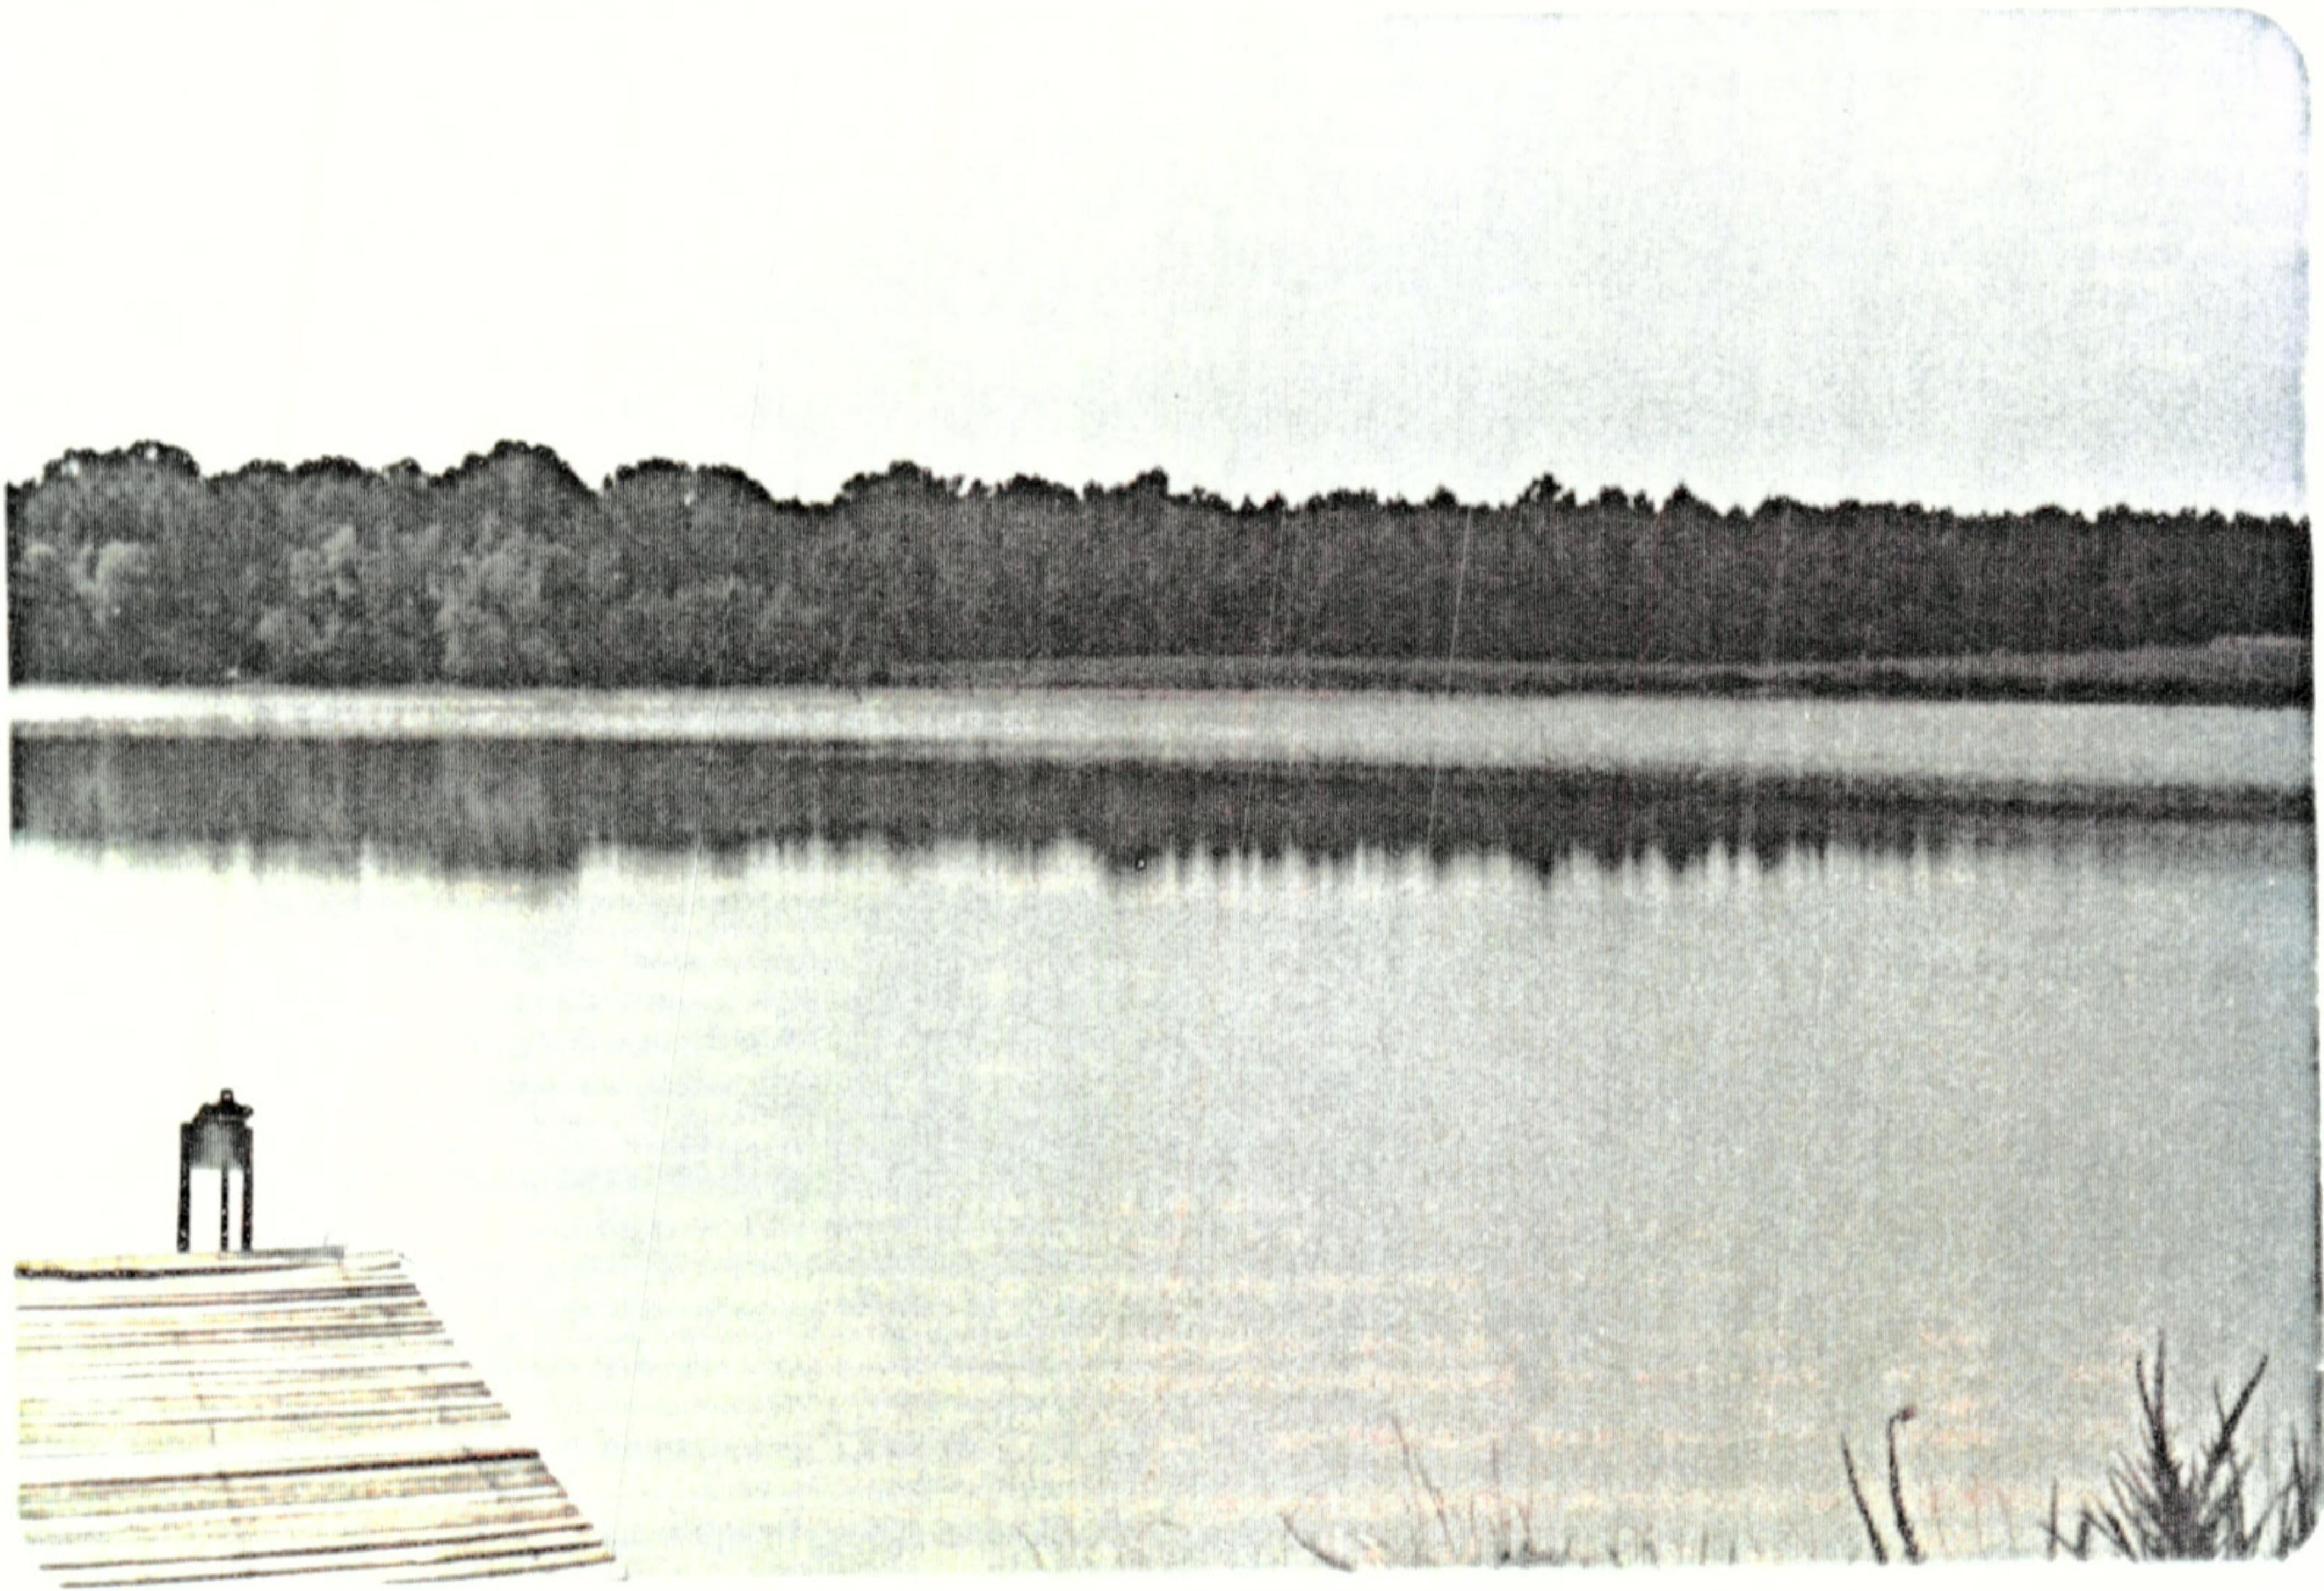
7. IMPOUNDMENT AREA

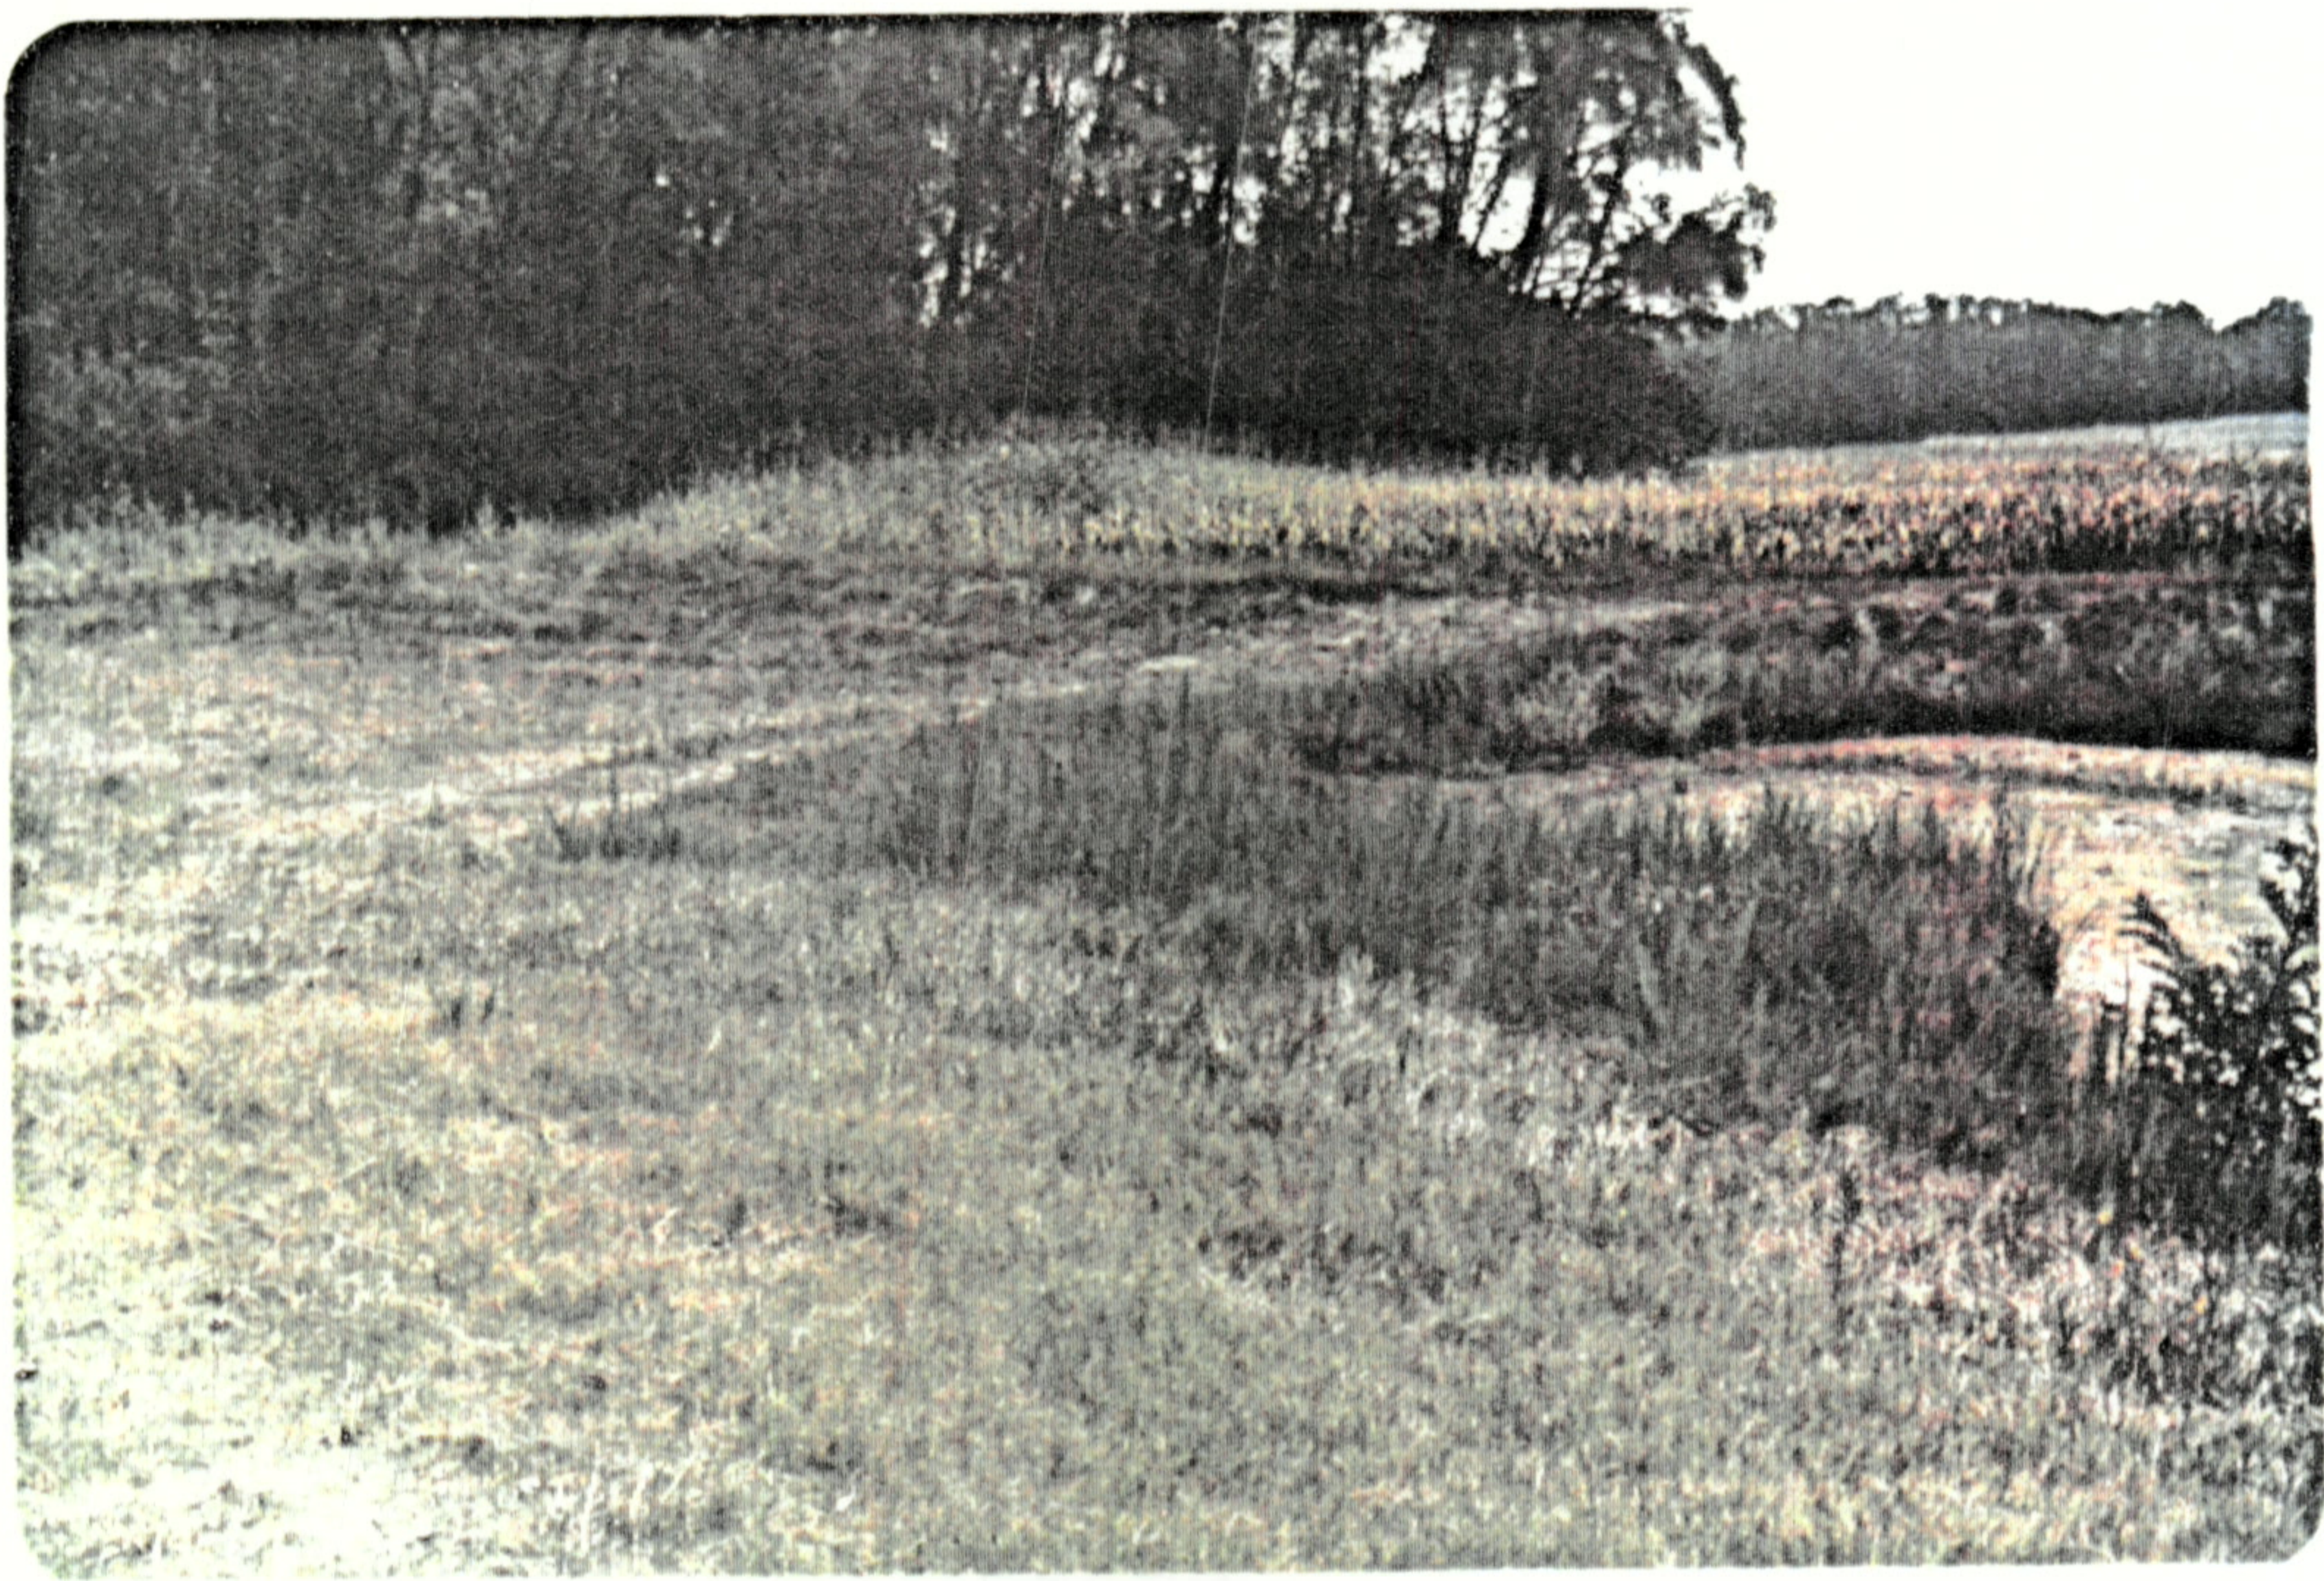
3.5 Conclusion and Recommendation. The design is considered adequate since the spillway will pass the SDF with 3.5 foot of freeboard. The spillway appears to be operating satisfactorily.

8. VIEW OF SPILLWAY
